# Biological Reconnaissance Assessment for 21396 Chino Hills Fire Station 68 Project

July 17, 2023

## **Subject: Biological Reconnaissance Assessment for Report regarding the Fire Station 68 and the Essential Resource Facility (ERF) South of Intersection of Pipeline Avenue and Soquel Canyon Road, Chino Hills, California**

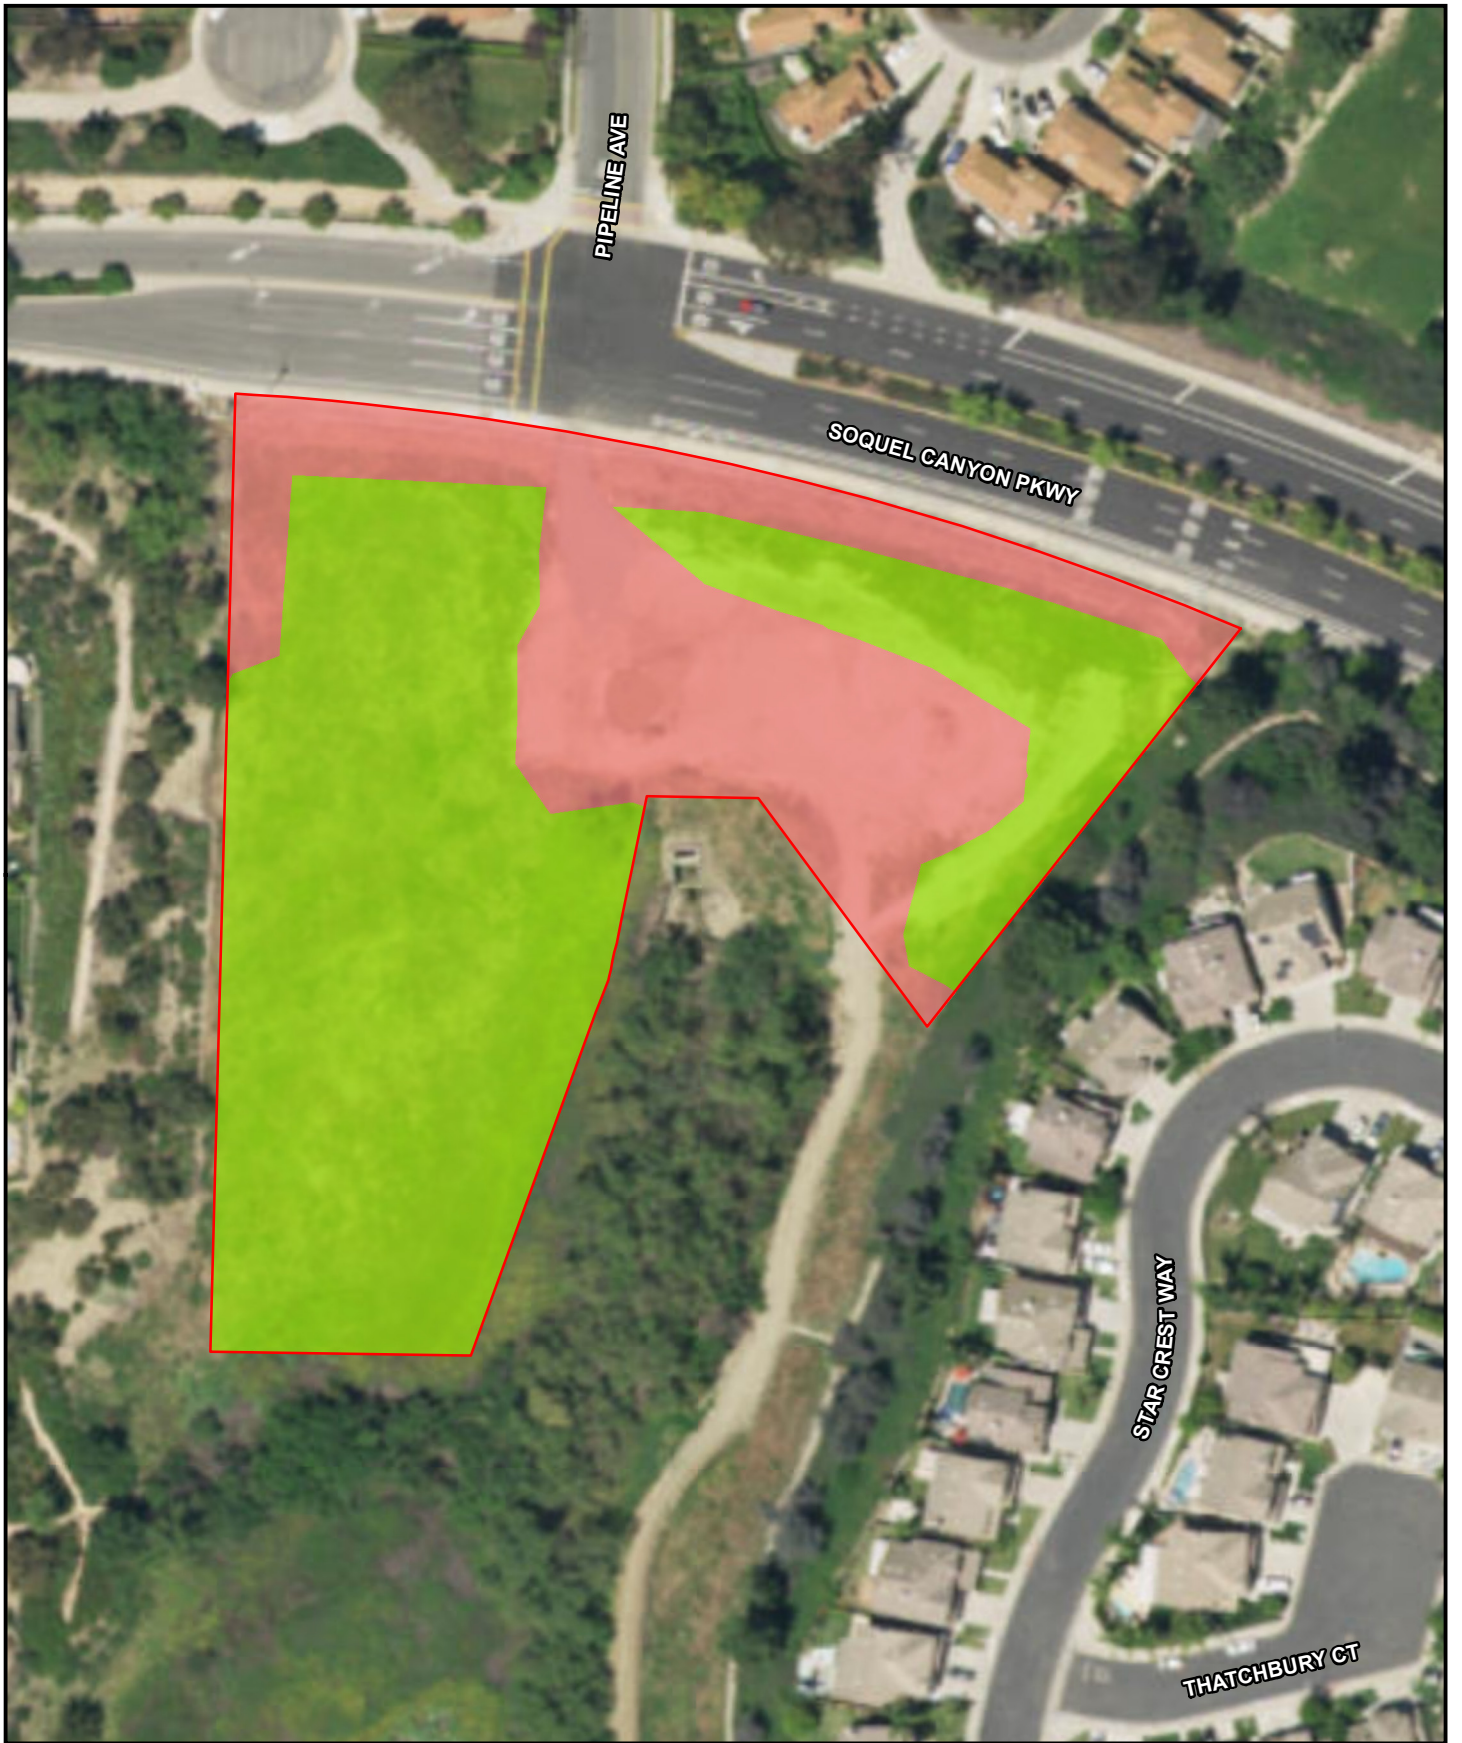
**Figure 3**  
Chino Valley Fire Station 68  
Vegetation Communities

- Project Location
- Vegetation Communities**
- Bare Ground/Disturbed
- Non-Native Grassland

Two vegetation communities or land types were found within the Project site during the biological reconnaissance survey, Bare Ground and Non-Native Grassland. The majority of the Project site is comprised of Non-Native Grassland. The communities are described in the following subsections.

Bare Ground areas are generally devoid of vegetation but do not contain any form of pavement. Bare Ground has higher water permeability and higher fossorial rodent habitat potential. Bare Ground is present throughout the northern portion of the Project site.

Non-Native Grassland was present throughout the majority of the Project site. Native species identified within this community within the Project site included common fiddleneck (*Amsinckia menziesii*), mediterranean stork's-bill

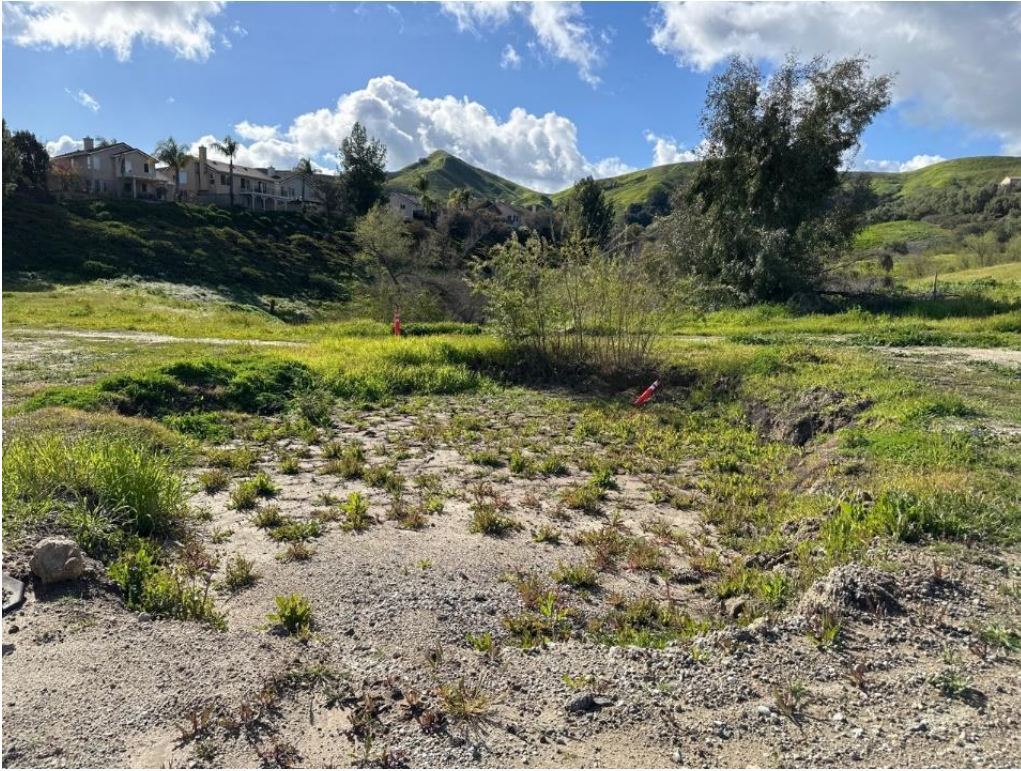
Photo 5.  
Photo depicts depression from disturbance with willows at the southern end of depression. Photo facing south.

One small depressional area was observed within the middle portion of the site near the northern boundary. The depressional feature is likely the result of human disturbance and manipulation of the area. Based on historical imagery of the area, the depression appears to have been excavated in 2014, and the site appears to be maintained on an annual basis. Currently, the area is composed primarily of non-native grasses with the exception of a few immature arroyo willow (*Salix lasiolepis*) and one Peruvian pepper tree (*Schinus molle*) located along the southern side of the depression. The area lacked evidence of hydrology and a test soil pit revealed non-hydric soils. Based on a lack of hydrological connectivity to a water feature in the area and the lack of hydric soils, this area is not classified as a wetland.

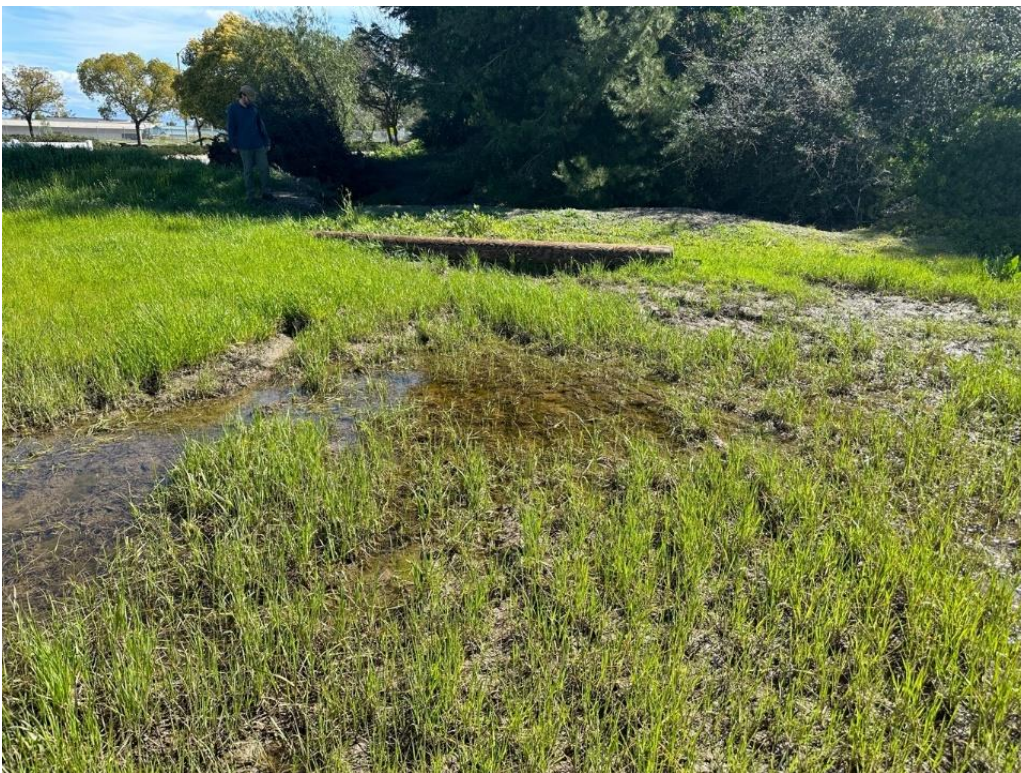
Photo 6.  
Photo depicts the potential wetland in the northeast corner of the Project site. Photo facing northeast.

In addition, two areas inundated with water were observed within the northeast and northwest corners of the Project site. No hydrological features (i.e., ordinary high water mark, channelization, flow patterns) were observed in this area. Both areas are fed solely by nuisance water from the sprinklers located along the adjacent hillsides for ornamental vegetation within the residential community. Soil pits were investigated in each area. Soil pit one was taken in the northwest area and revealed a soil characteristic of 2.5y 4/1 with 10 percent redox of 2.5y 7/8 and consisted of clay loam. Evidence of hydrology included saturated soils and a water table at 10 inches. No hydrophytic vegetation was observed within the area. Soil pit two was taken in the northeast area and revealed a soil characteristic of 2.5y 4/1 with no redox and consisted of sandy clay loam. Evidence of hydrology included saturated soils and a water table at 3 inches. No hydrophytic vegetation was observed within the area. As stated above, both areas are fed completely by nuisance water from the surrounding residential community and lack any natural sources of hydrology or connectivity to hydrologic features. In addition, both areas lack hydrophytic vegetation. Therefore, neither inundated area qualifies as a wetland. Wetland determination forms are provided in Attachment 5.

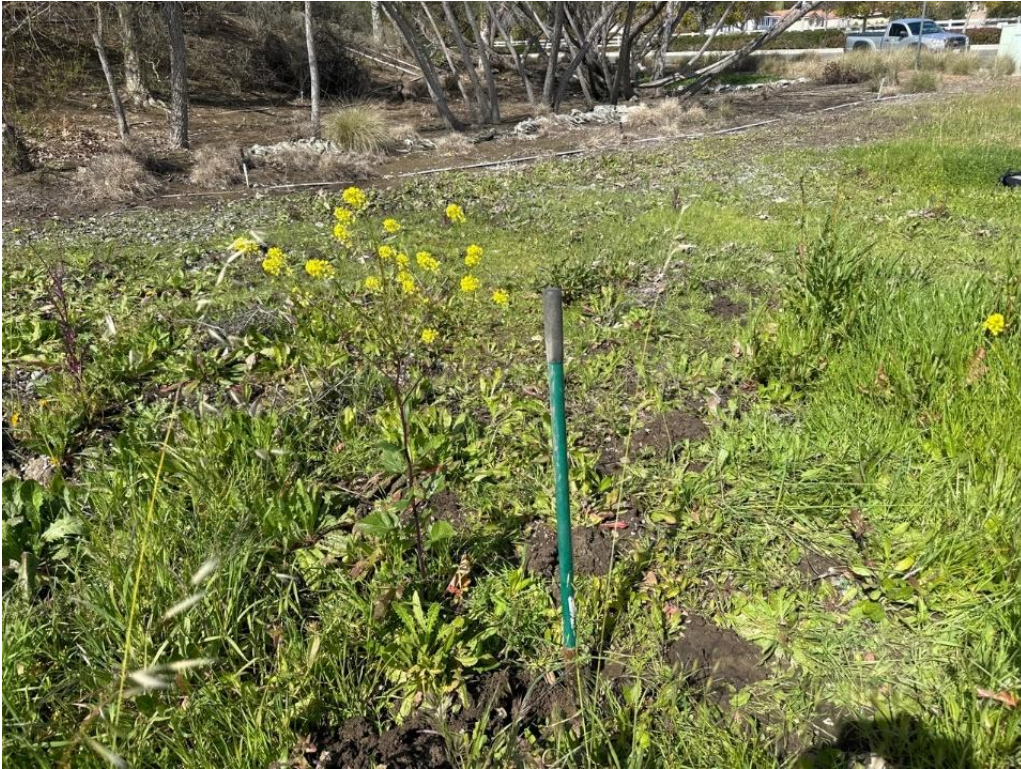
Photo 7.  
Photo depicts Soil Pit 1 taken near the northwest corner. Photo taken facing northwest.

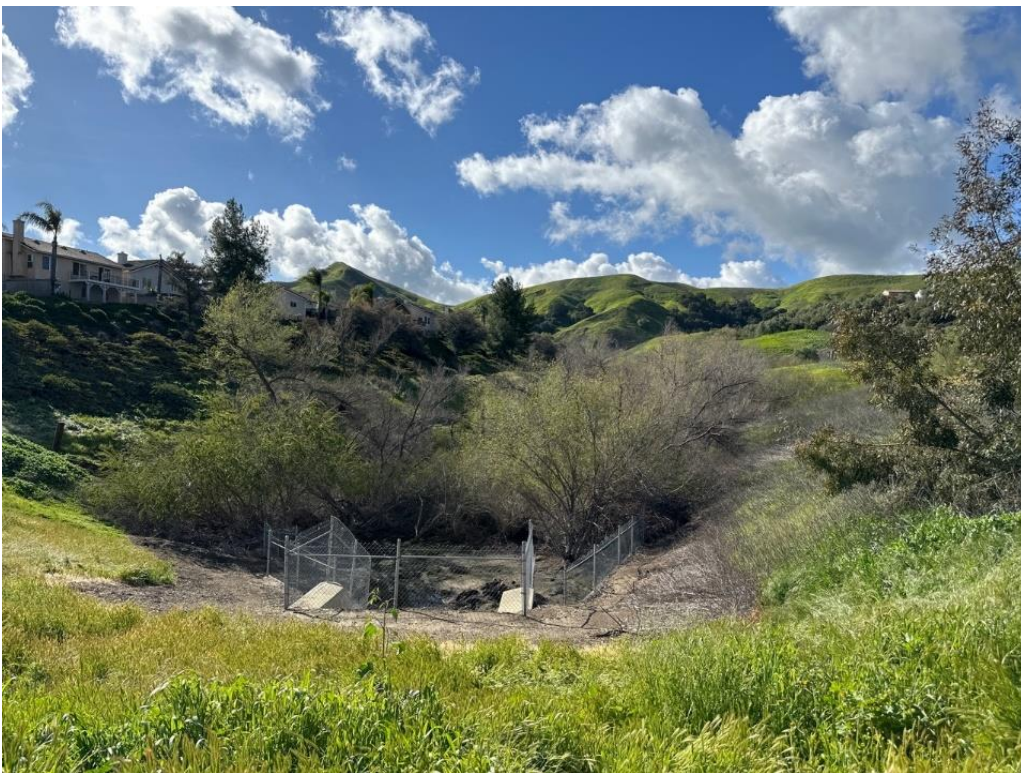
Photo 8.  
Photo showing the riparian vegetation within the drainage and the concrete culvert that runs under the Project site, located outside the southeast portion of the Project boundary. Photo facing south.

the development of the residential neighborhood surrounding the site. The feature now flows north through a cement-lined culvert located south and outside of the Project boundary, goes subsurface under the site, and continues under Soquel Canyon Parkway in a northeast direction. The drainage facilitates flow during storm events from the hills to the south within Chino Hills State Park.

A large drainage and culvert occur directly south/southwest (outside) of the Project site. Work will not occur outside of the proposed Project boundaries; therefore, no impacts to this drainage is anticipated to occur as a result of the Project. The two small inundated areas lack any connectivity to hydrologic features and are not considered wetlands; therefore, no impacts to jurisdictional waters or wetlands are anticipated to occur as a result of Project activities. In order to minimize temporary impacts to drainage and culvert located to the south, BMP's including silt fencing and straw waddle are recommended throughout construction activities.

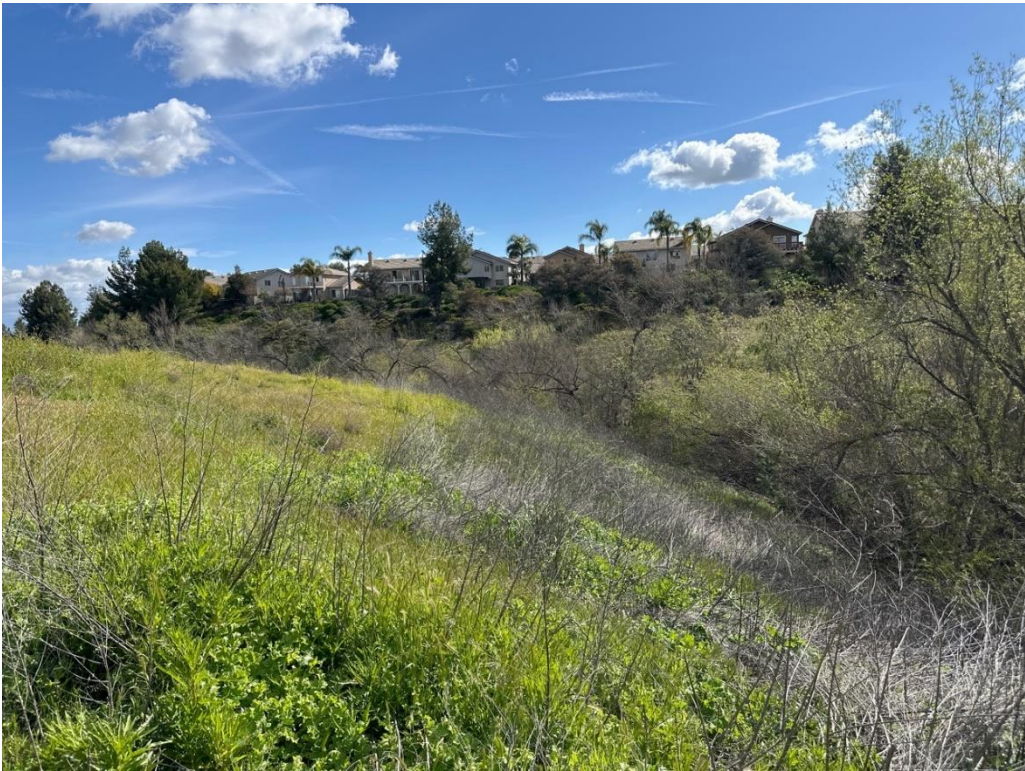
Photo 9.  
Photo showing the riparian vegetation and drainage located south/east of the site. Photo facing northeast.

Only one drainage feature was observed during the survey, located outside (south) of the Project. No impacts are anticipated to occur to the drainage feature; therefore, no impact to waters of the United States or waters of the State are anticipated to occur as a result of this Project.
